USAAVLABS TECHNICAL REPORT 70-3

1100-HP ROLLER GEAR DRIVE

U. S. ARMY AVIATION MATERIEL LABORATORIES FORT EUSTIS, VIRGINIA

CONTRACT DA 44-177-AMC-30(T)
TRW MECHANICAL PRODUCTS DIVISION
CLEVELAND, OHIO

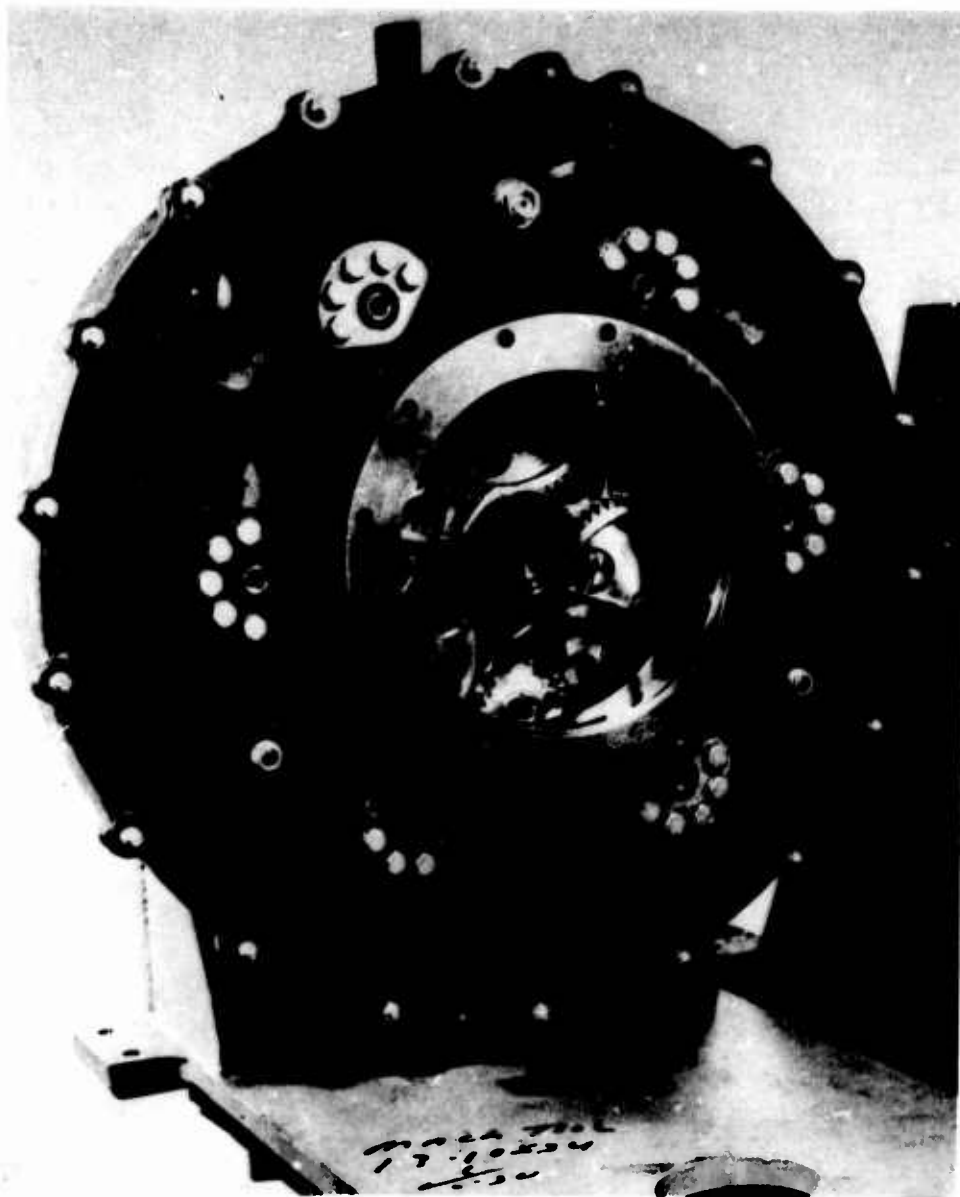
Figure 12. Roller Gear Support Housing.

The roller gear support housing was machined from a magnesium casting. Six equally spaced bosses were provided for support of the second-row roller gear shafts. Stainless steel liners were pressed into 1.177/1.197-in.-diameter through-holes in each of the bosses. When assembled with the cover, these liners were bored and reamed to 1.0000/1.0007-in.-diameter to slip-fit with the roller gear shafts. At this time, five .457/.472-in.-diameter through-holes were drilled around each of the six liners for attachment bolts for installing the roller gear shafts (Figure 13). Six equally spaced 2.000-in.-diameter inspection holes were provided for inspection of the second-row roller gears, X_2 , and ring gear, C. These were sealed at assembly by installing flat disk plates with annular O-ring seals. The disks were secured in the holes by installing snap rings on either side of the disk plates.

This support housing contains the mounting flange with twelve bolt holes for attaching the bevel gear duplex bearing support and the bevel gear housing. Three through-holes and two threaded bosses were provided for installing the roller gear lube system manifold. The housing pilot (24.870/24.866-in.-diameter) contains an annular O-ring seal when assembled with the cover.

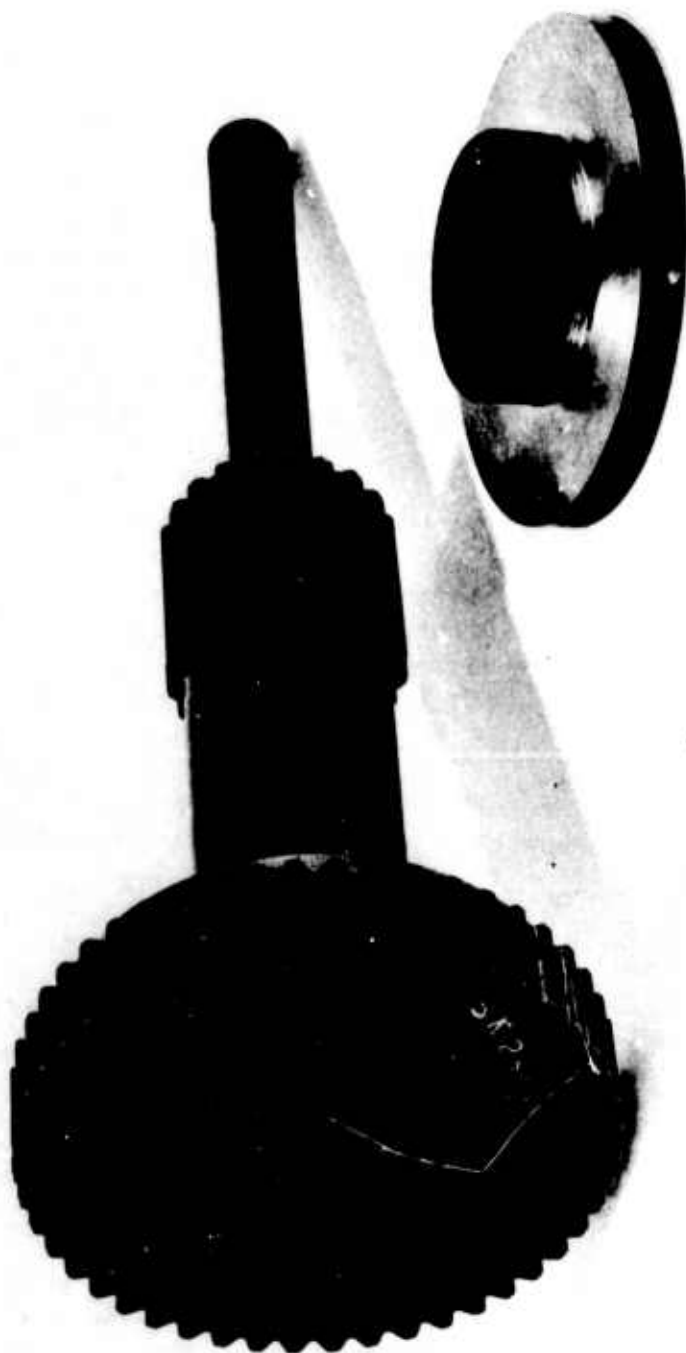
Figure 14. Drive Shaft.

The drive shaft, which transmits torque from the driven bevel gear to the roller gear drive sun gear, A, through a coupling and coupling adapter, engages at the sun gear internal spline. The drive shaft, which is reduced to 1/2-in. diameter beyond the internal spline engagement, extends through the sun gear ID and is threaded on the end. A washer with pilot shoulder which slip-fits into the sun gear ID was placed on the end of the drive shaft threaded end, and a 1/2-in. lock nut was installed on the shaft. This draws the sun gear stackup together and places the sun gear end thrust collars in bearing on the drive shaft shoulder at the input end and on the washer flange at the opposite end. The drive shaft input or large spline is identical to the coupling adapter spline, which was internally splined and locked to the bevel gear output shaft with a flat washer and lock nut (Figure 14). The two splines were engaged with an internally splined drive coupling. The coupling is axially retained by two internal snap rings, which limit axial movement at either spline end.

The drive shaft, coupling, and coupling adapter were made from 4340 steel, heat-treated to R_c 33-38 hardness. All spline teeth were shaped with a surface roughness of 63μ in.

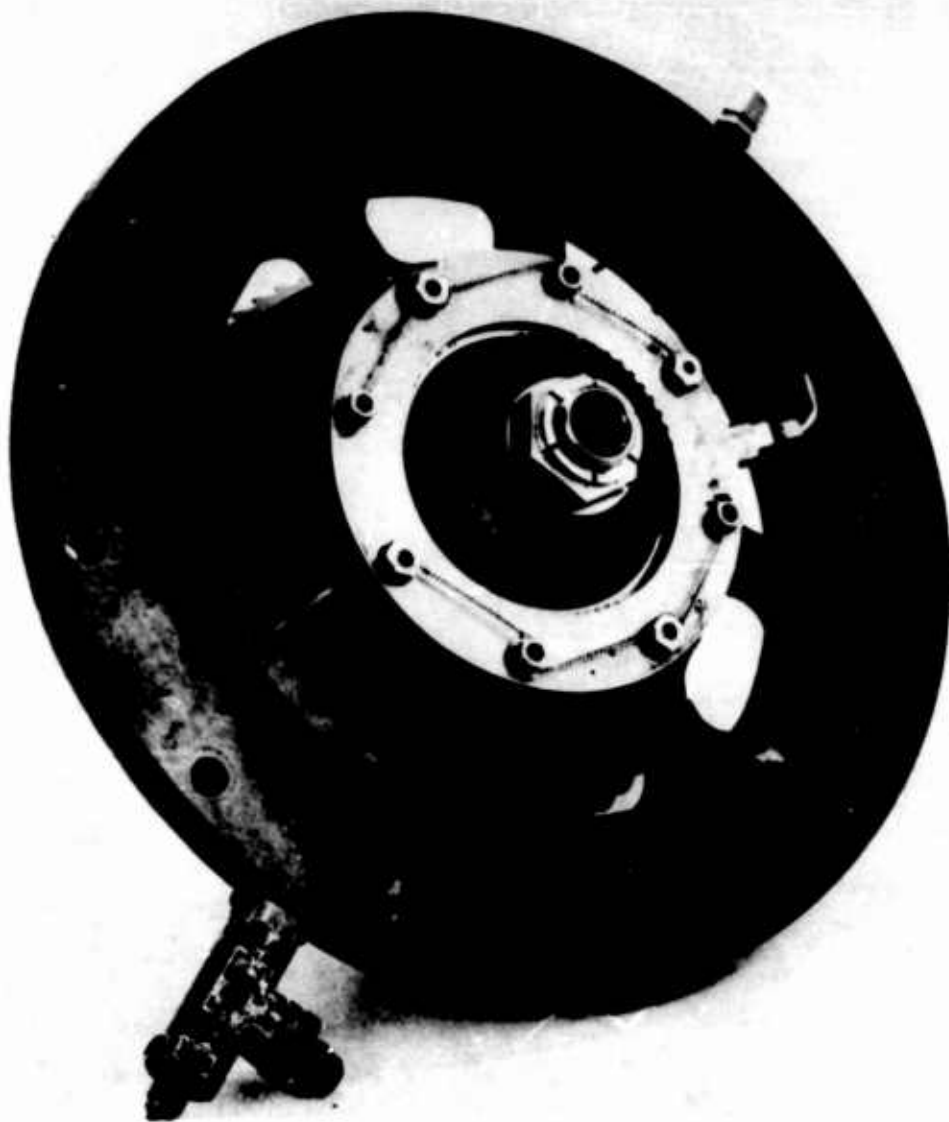
Figure 20. Bevel Gear/Shaft and Bearing Support Assembly.

The two angular contact bearings were slip-fit into a stainless steel liner, which in turn, was pressed into the magnesium bearing support. The bearings were retained axially by retainer plates at either end which were bolted to the bearing support (Figure 20).
